MICROCHIP PIC16F631/677/685/687/689/690

PIC16F631/677/685/687/689/690 Rev. A Silicon/Data Sheet Errata

The PIC16F631/677/685/687/689/690 parts you have received conform functionally to the Device Data Sheet (DS41262E), except for the anomalies described below.

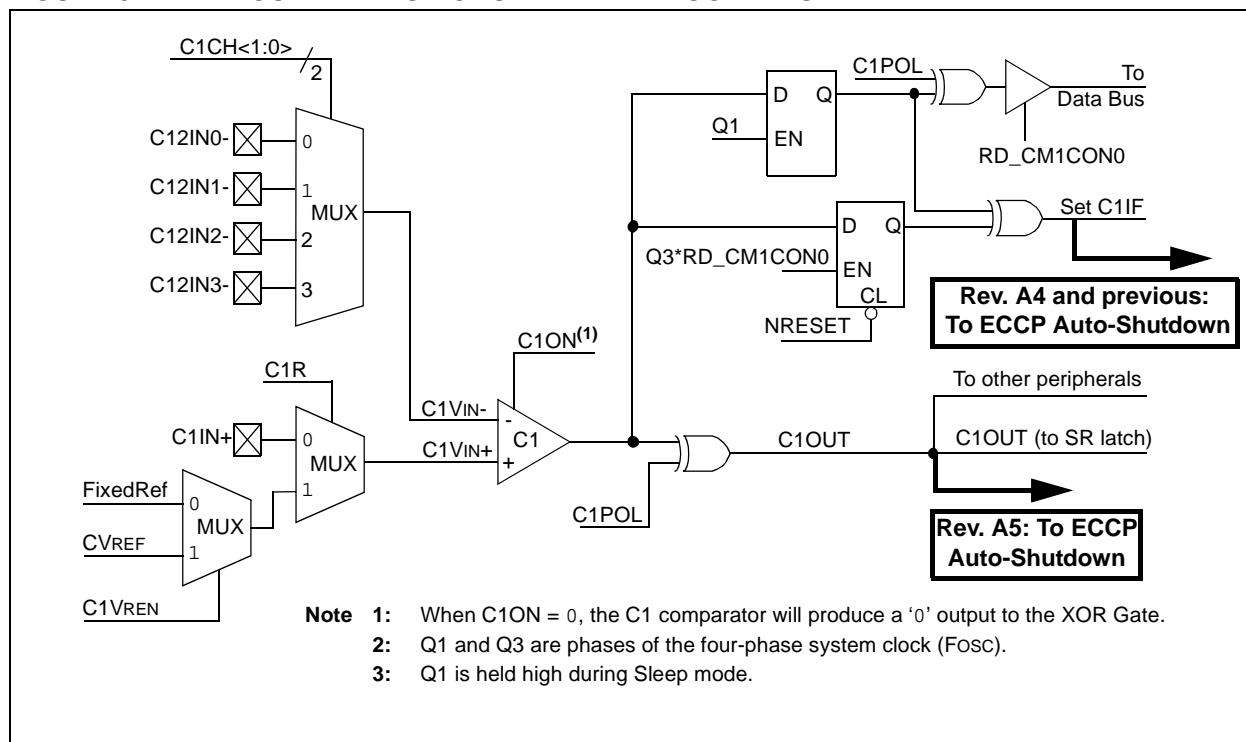
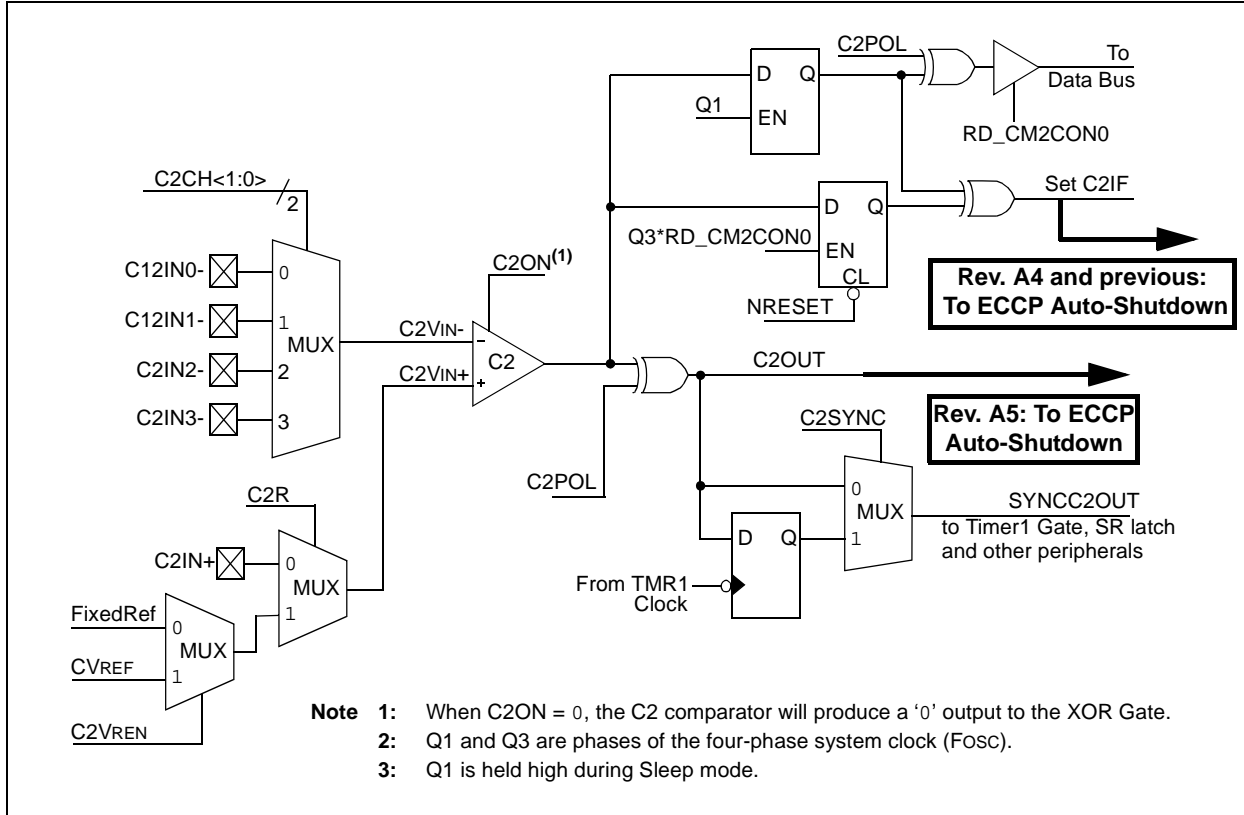
The PIC16F631/677/685/687/689/690 Rev. A4 silicon for the ECCP auto-shutdown is connected to the C1IF and C2IF flags. See Figures 8-2 and 8-3 on the following page.

The auto-shutdown connection (Rev. A4 and previous) to C1IF and C2IF causes the auto-shutdown to incorrectly operate synchronously. Additionally, reads of CMxCON0 will incorrectly clear an auto-shutdown event.

- 1) Poll the CxOUT bit until it is low.
- 2) Read CMxCON0 to precondition CxIF.
- 3) If CMxCON0 is read while CxOUT is changing, repeat steps 1 and 2.

The Silicon Rev. A5 (now shipping) and later revision devices have moved the auto-shutdown connection from CxIF to CxOUT. This will eliminate the synchronous shutdown and simplify the use of the comparator for a shutdown event. Figure 1 shows the function of auto-shutdown before and after the device revision.
