MICROCHIP PIC18F2420/2520/4420/4520

PIC18F2420/2520/4420/4520 Rev. B4 Silicon Errata

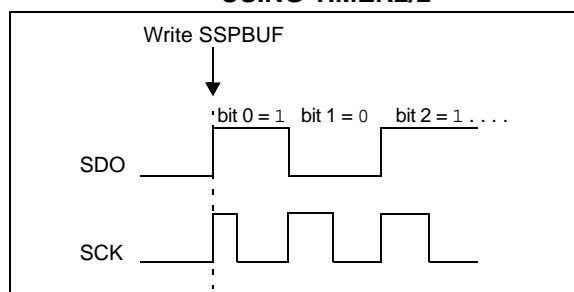
FIGURE 1: SCK PULSE VARIATION USING TIMER2/2

When the SPI is using Timer2/2 as the clock source, a shorter than expected SCK pulse may occur on the first bit of the transmitted/received data (Figure 1).

To avoid producing the short pulse, turn off Timer2 and clear the TMR2 register, load the SSPBUF with the data to transmit and then turn Timer2 back on. Refer to Example 1 for sample code.
