**MICROCHIP****PIC18F2410/2510/4410/4510****PIC18F2410/2510/4410/4510 Rev. A1 Silicon Errata**

The following silicon errata apply only to PIC18F2410/2510/4410/4510 devices with these Device/Revision IDs:

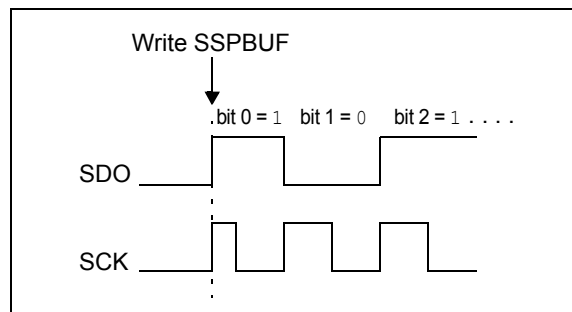
**FIGURE 1: SCK PULSE VARIATION USING TIMER2/2**

When the SPI is using Timer2/2 as the clock source, a shorter than expected SCK pulse may occur on the first bit of the transmitted/received data (Figure 1).

To avoid producing the short pulse, turn off Timer2 and clear the TMR2 register, load the SSPBUF with the data to transmit and then turn Timer2 back on. Refer to Example 5 for sample code.
