**MICROCHIP****PIC18F2423/2523/4423/4523****PIC18F2423/2523/4423/4523 Rev. B4 Silicon Errata**

The PIC18F2423/2523/4423/4523 Rev. B4 parts you have received conform functionally to the Device Data Sheet (DS39755B), except for the anomalies described below. Any Data Sheet Clarification issues related to the PIC18F2423/2523/4423/4523 will be reported in a separate Data Sheet errata. Please check the Microchip web site for any existing issues.

The following silicon errata apply only to PIC18F2423/2523/4423/4523 devices with these Device/Revision IDs:

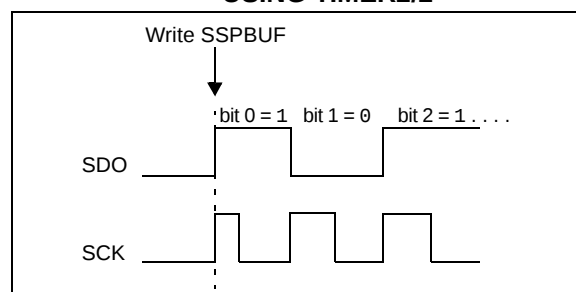
**FIGURE 1: SCK PULSE VARIATION USING TIMER2/2**

When the SPI is using Timer2/2 as the clock source, a shorter than expected SCK pulse may occur on the first bit of the transmitted/received data (Figure 1).

To avoid producing the short pulse, turn off Timer2 and clear the TMR2 register, load the SSPBUF with the data to transmit and then turn Timer2 back on. Refer to Example 1 for sample code.
