# ***3 Volt Intel StrataFlash<sup>®</sup> Memory***

## ***28F128J3, 28F640J3, 28F320J3***

### **Specification Update**

Order Number: 298130-015

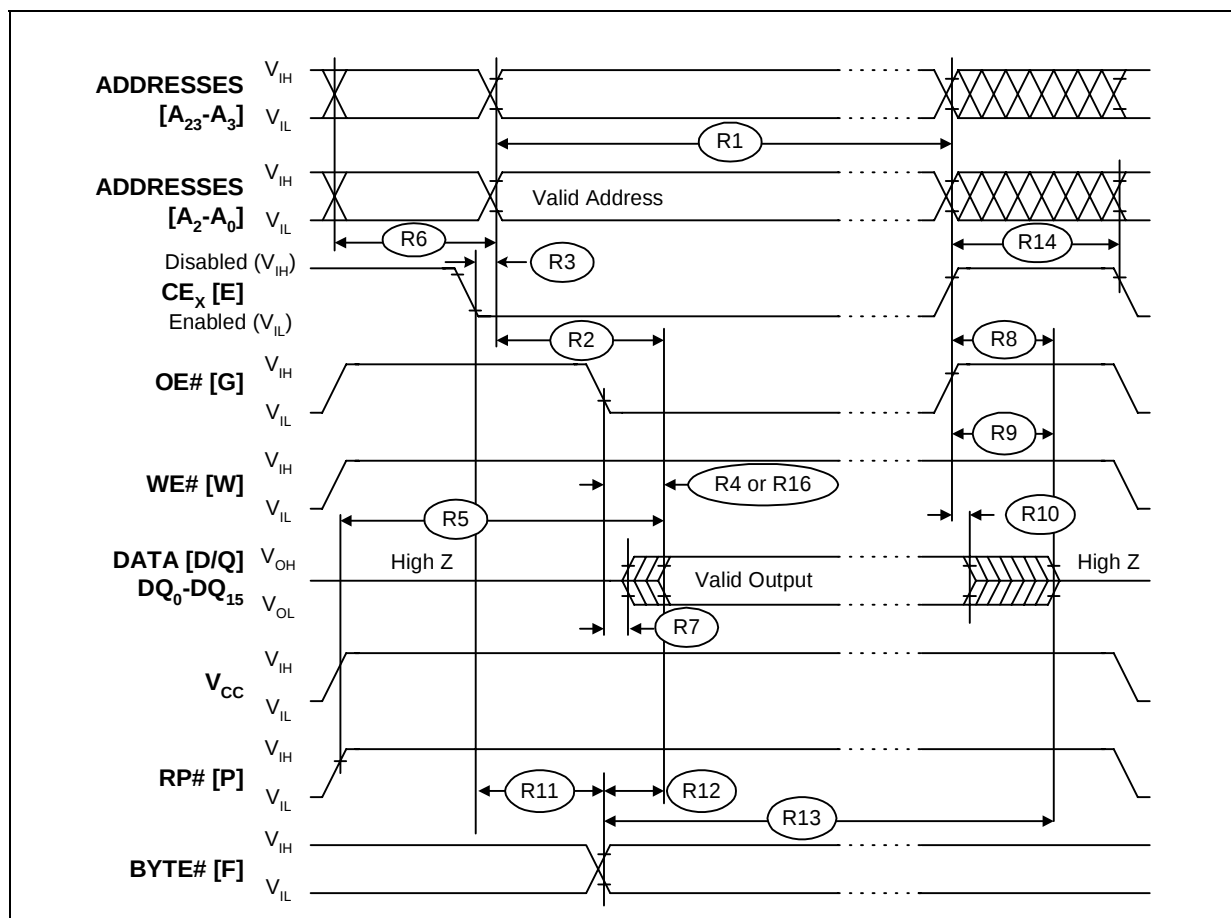
Figure 1. AC Waveform for Standard Word/Byte Read Operations

Problem: Devices need the parameter  $t_{ELQX}$  = 150 ns minimum. CE low to output in low Z ( $t_{ELQX}$ ) is designated as R6 in Figure 1, in this Specification Update revision.

Problem: Devices need the parameter  $t_{ELAV}$  = 500 ns maximum. Chip Enable to Address Valid ( $t_{ELAV}$ ) is designated as R3 in Figure 1, in this Specification Update revision.

Workaround: Use devices for initial lower volume prototype development.
