# Intel<sup>®</sup> 80312 I/O Companion Chip

*Specification Update*

*November 2001*

Order Number: **273416-006**

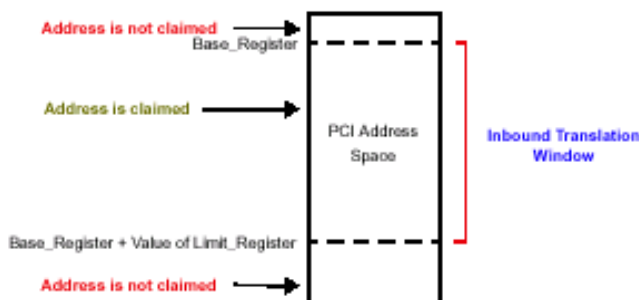
**2. Figure 5-3 on page 5-7 has missing text**

**Problem:** The figure shows 'se\_Register + Value...'. It should be 'Base\_Register + Value...'.

**Workaround:** Replace Figure 5-3 with the following:

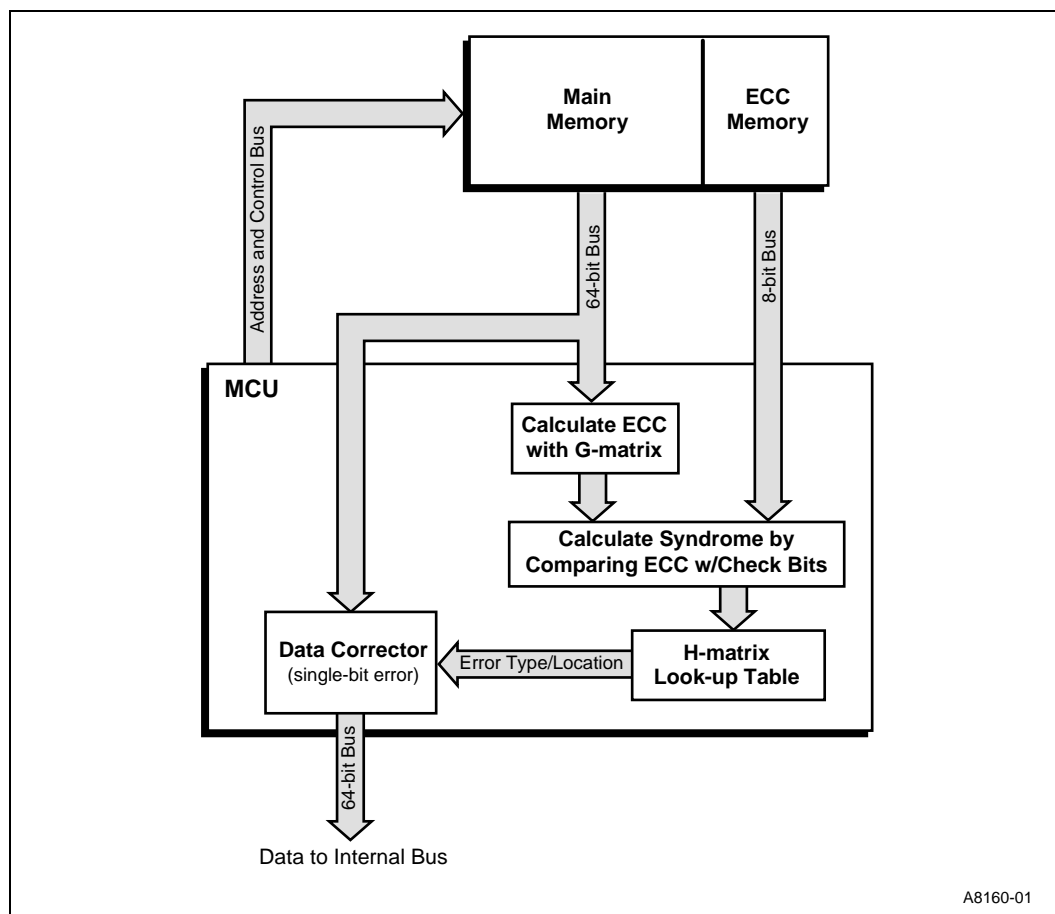
**Figure 3-17. ECC Read Data Flow**

**Problem:** Syndrome Decoding Error Types and Symptoms are incorrectly stated.

Figure 3-17 shows how the data flows through the ECC hardware for a read transaction.

**Workaround:** Replace Table 3-13 with the following and, add the adjacent paragraph with “new” Figure 3-17:
