dsPIC30F6011/ 6012/6013/6014

dsPIC30F6011/6012/6013/6014 Rev. B2 Silicon Errata

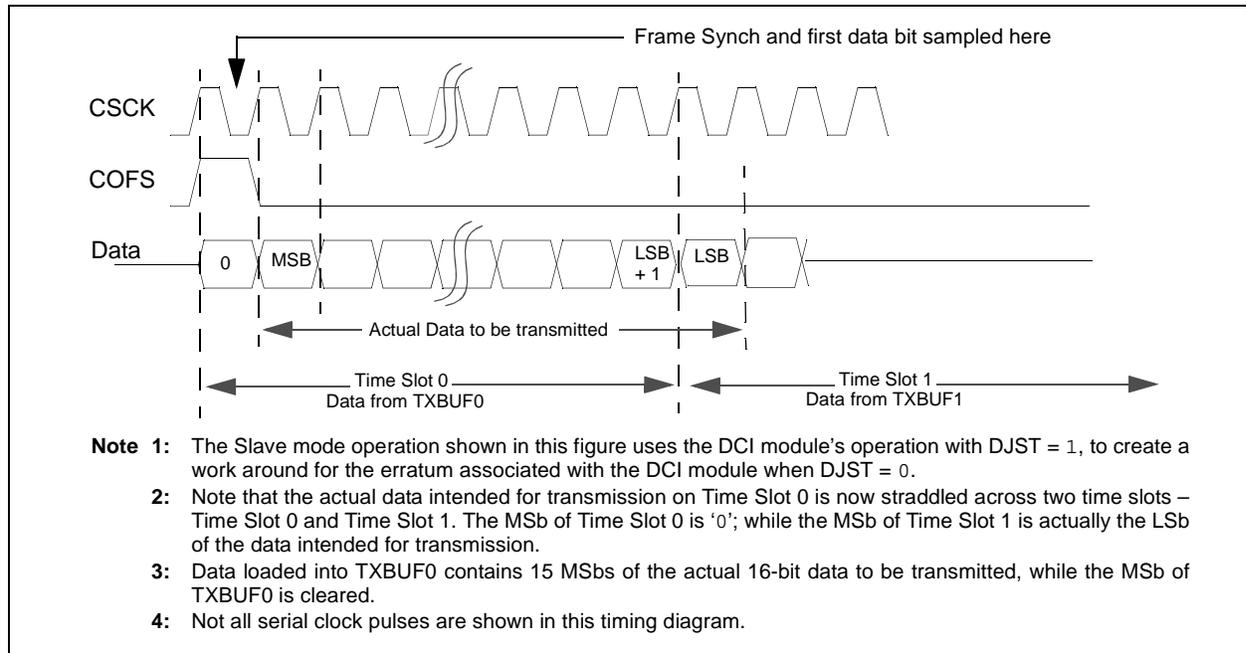
FIGURE 1: DCI SLAVE WORK AROUND

The Data Converter Interface (DCI) module does not function correctly in Slave mode when the following conditions are true:
