# MCF5282 Device Errata

Supports: MCF5281 and MCF5282

MCF5282DE  
Rev. 5  
2/2009

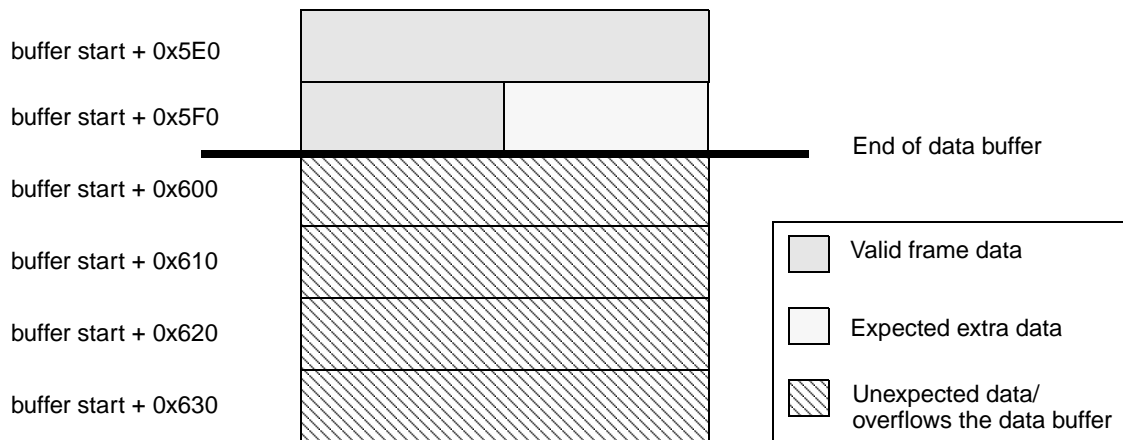
Figure 1. Buffer Overrun Example

When the FEC is connected to a 10BaseT network, if length of the data stored in a descriptor is not evenly divisible by 16 (not line-aligned), the FEC writes extra lines at the end of the buffer. The entire line that contains the last valid data is written and at least one extra line, but up to four lines after the end of the valid data can also be written. In most cases, this is not a problem because the extra lines of data continue falling within the limits of the buffer. However, if the valid data ends near the end of the buffer, the extra lines written by the FEC might be outside of the data buffer. This leads to corruption of the next buffer, descriptor, data, or code stored in the adjacent memory.

For example, as shown in [Figure 1](#), if the max buffer size is programmed to 0x600 and a frame that is 0x5F8 bytes long is received, a line is written starting at buffer start + 0x5F0. The first half of the line at buffer start + 0x5F0 is valid frame data that should be processed by the FEC driver; the second half of the line is additional data that is written because the FEC only writes complete lines. This data should be ignored by the FEC driver. So far, this is correct FEC behavior as originally specified. However, the FEC repeats the last line of valid data a number of times. The line at buffer start + 0x600 is written, and as many as three additional lines beyond the end of the data buffer could be written.

There are three independent workarounds:

1. Only use 100BaseT.

2. Allocate extra lines for the receive data buffers. The actual allocated memory for each buffer should be equal to the receive buffer size programmed in the FEC's EMRBR register plus four lines (16 byte-sized lines).
3. Program the data buffer size one line larger than the max packet size (data buffer size = EMRBR + 0x40).
