MCP98242 Rev. A1 Silicon Errata

The MCP98242 parts you have received conform functionally to the Device Data Sheet (DS21996B), except for the anomalies described below.

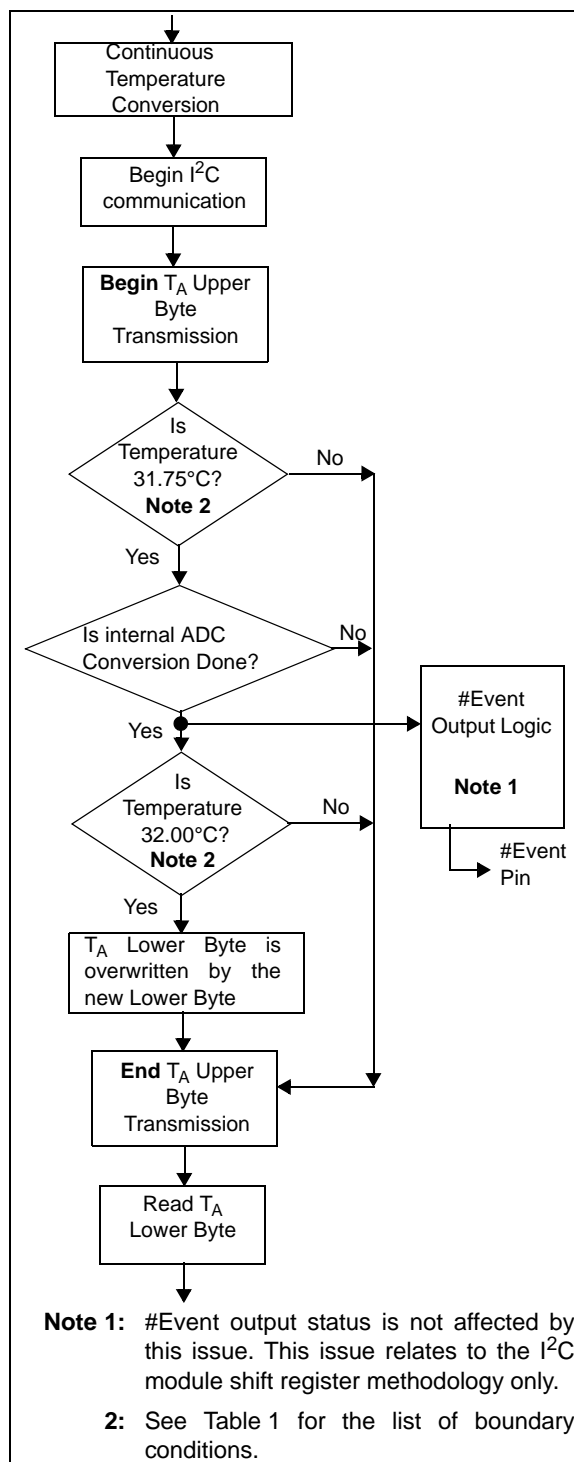
FIGURE 1: Flow Chart.

Under the specific boundary conditions listed below, the 2 byte temperature register T_A may contain temperature data $+16^\circ\text{C}$ or -16°C from the nominal temperature due to internal data synchronization issue.

Byte 1 must be in I²C transmission for this issue to occur and the ADC must complete conversion while I²C is in communication. In addition, the ambient temperature must be at multiples of $16^\circ\text{C} \pm 0.25^\circ\text{C}$ for the temperature register to be partially overwritten.

The Figure 1 shows flow diagram describing the specific conditions for the synchronization issue occurs. Table 1 shows a complete list of temperatures greater than 0°C .

If the ambient temperature read is within the host temperature limit, then do nothing. Otherwise, if the new temperature read is greater than or less than the previous temperature data by exactly 16.00°C, then perform a Repeat Read to receive the correct temperature data. There is a 0% probability that the Repeat Read data would be corrupted, if the Repeat Read is performed within T_{CONV} (65 ms). If a Repeat Read is performed after 65ms then there is a greater than 0% probability that the next conversion would also be corrupt by ±16.00°C as stated in Table 1. In this case, disregard this reading and perform a Repeat Read and compare the result with the last known good reading.

Devices on or after date code 0847 correct this issue.
