LXT9761/62/63/81/82 PHY Transceivers

Specification Update

November 2001

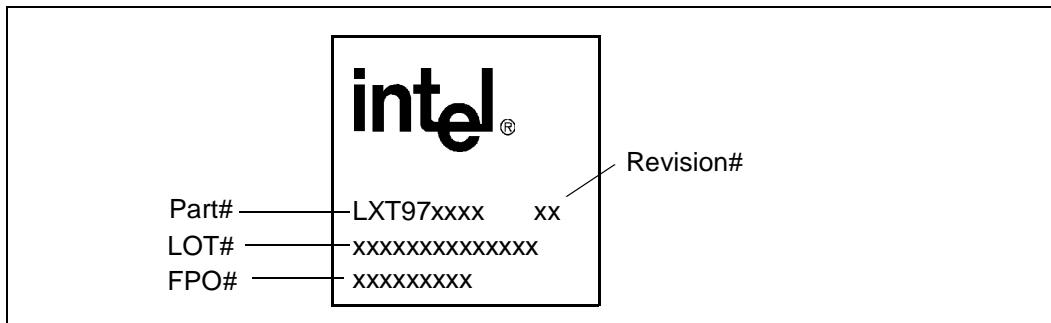
Markings

The silicon stepping in the LXT97xx Data Sheets is referred to as "Manufacturer's Revision Number." The silicon stepping number may be read by software from Register 3, bits 3:0 in the LXT97xx transceivers.

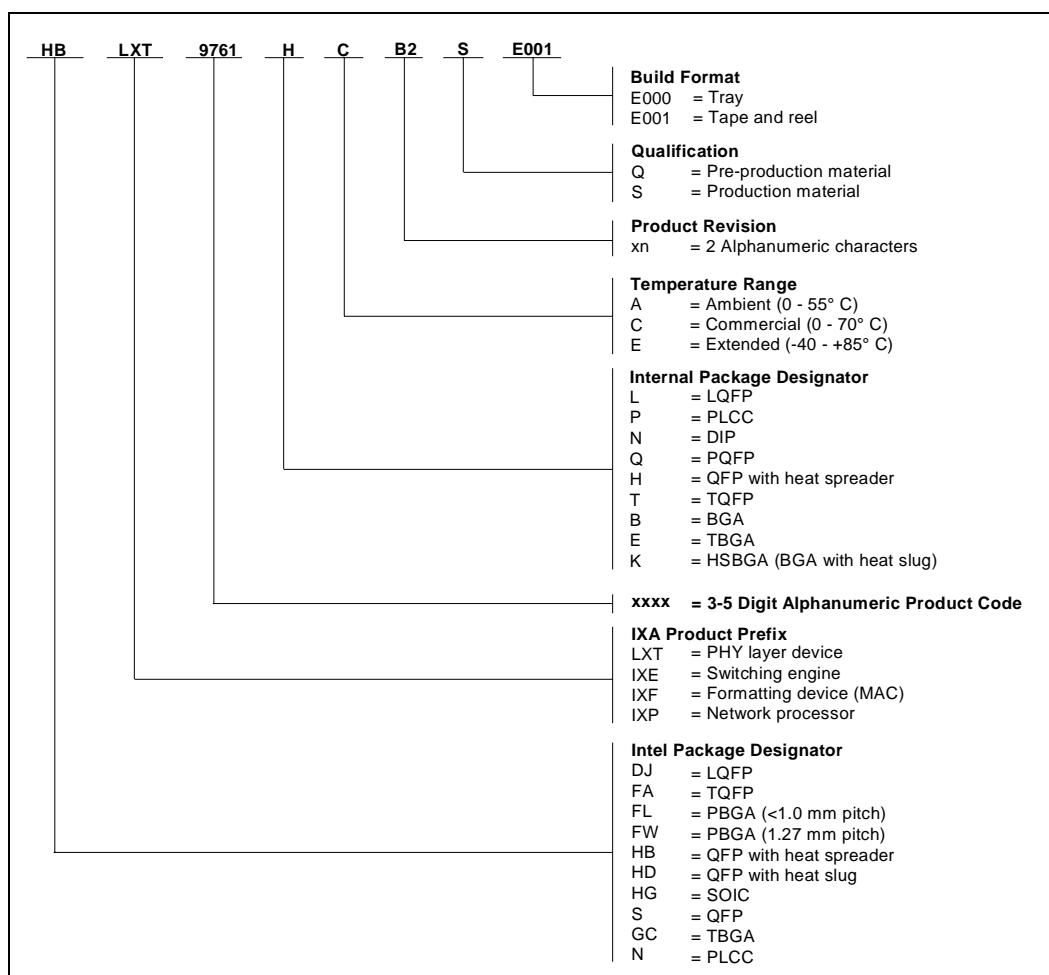
Figure 1. Order Information - Sample

Number	Revision	Qualification	Tray MM	Tape & Reel MM
HBLXT9761HC.C4	C4	S	837202	837198
HBLXT9762HC.C4	C4	S	835378	837199
HBLXT9763HC.C4	C4	S	834111	835082
HBLXT9781HC.C4	C4	S	834114	835086
FWLXT9781BC.C4	C4	S	834112	835083
HBLXT9782HC.C4	C4	S	837211	837200
FWLXT9782BC.C4	C4	S	834115	835085
